Qualitative On-Roof Infrared Moisture Survey Report

ON-ROOF INFRARED REPORT

Client: ABC Properties

Building location: 358 Midway Road, Anywhere, USA

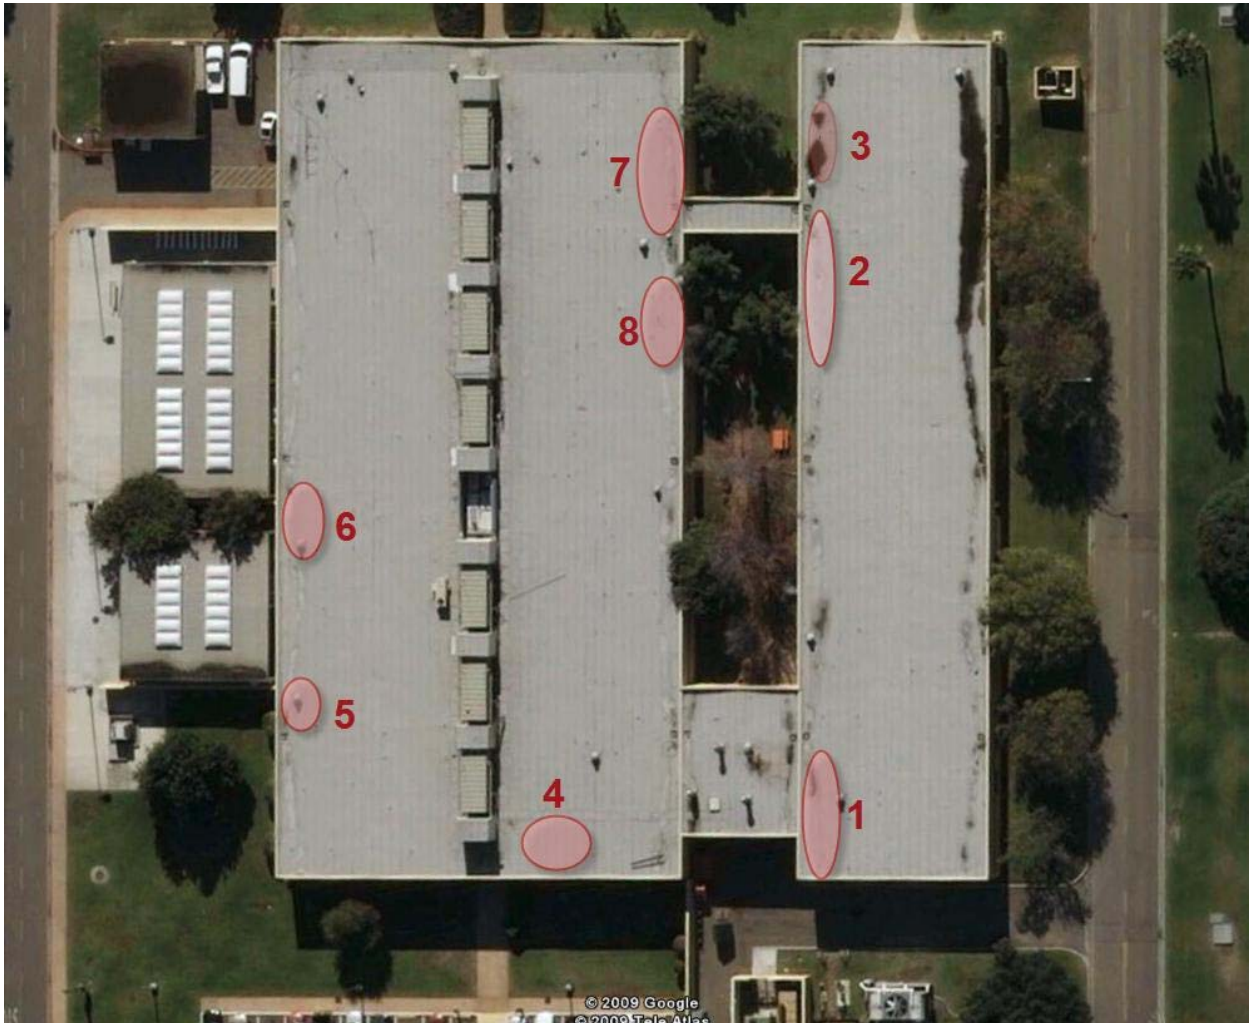
AREAS WITH PROBABLE MOISTURE

Circles on the image above represent areas of suspect moisture. The areas were scanned with a moisture meter and elevated moisture readings were taken. The numbers above, match the report number in the reports below.

Areas of wet insulation are marked directly on the roof. We recommend that a roof professional and your maintenance team carefully review this report. Then, with reference to the images contained herein and the marked areas on the roof, these areas should be physically located and given a thorough visual examination. When warranted, these areas should be subjected to a destructive test (core sample) to confirm the analysis.

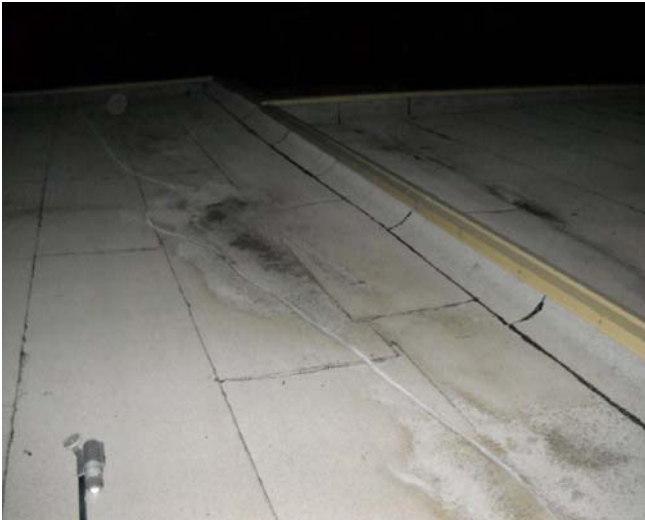
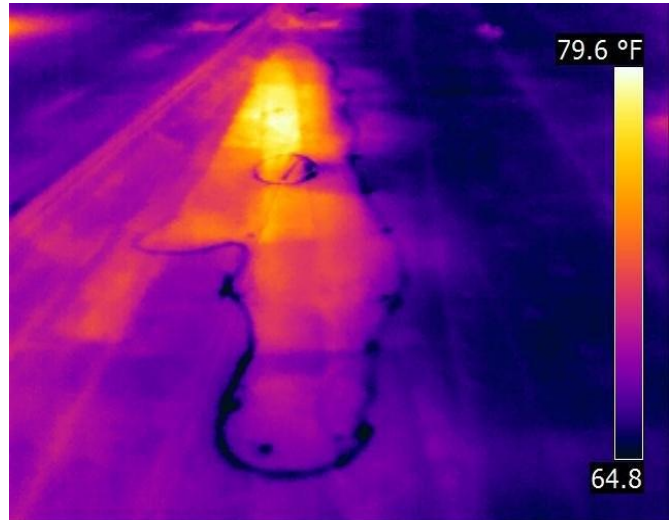
ANOMALY AREA: 1	Date: 8/6/2009 10:40:55	Notes: Suspect area of moisture as indicated.
------------------------	--------------------------------	--

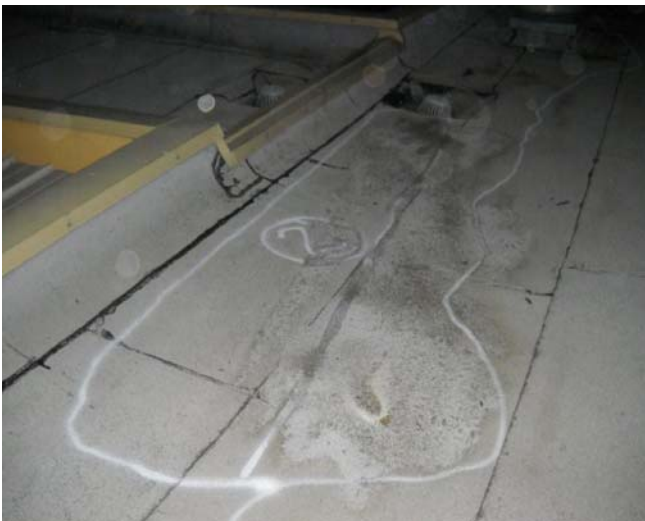
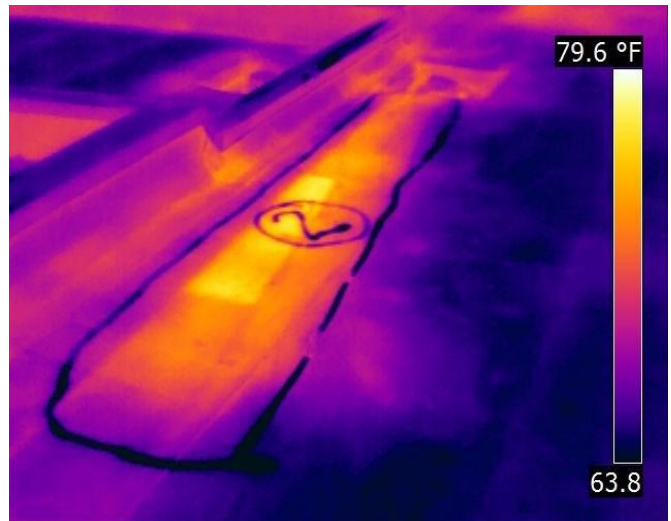
ANOMALY AREA: 2	Date: 8/6/2009 10:55:02	Notes: Suspect area of moisture as indicated.
------------------------	--------------------------------	--

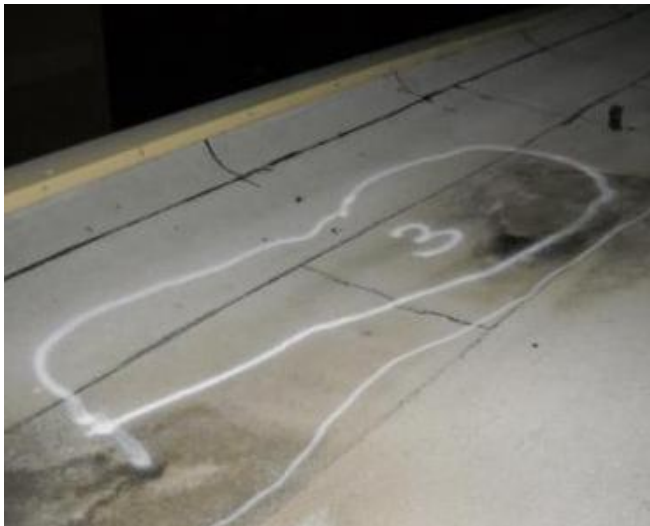
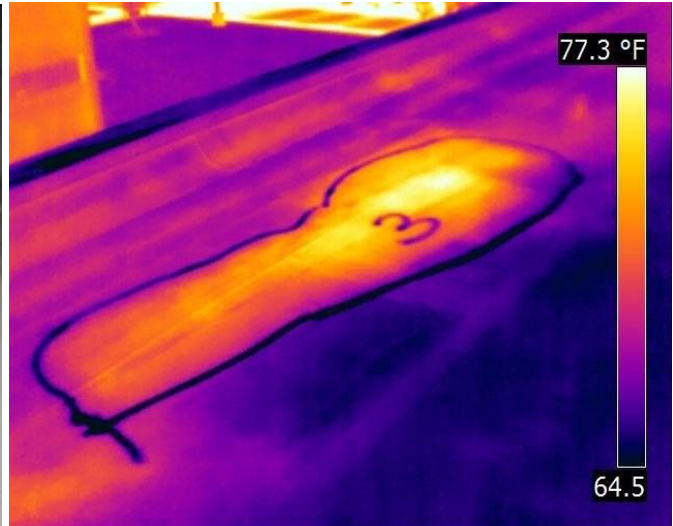
ANOMALY AREA: 3

Notes: Suspect area of moisture as indicated.

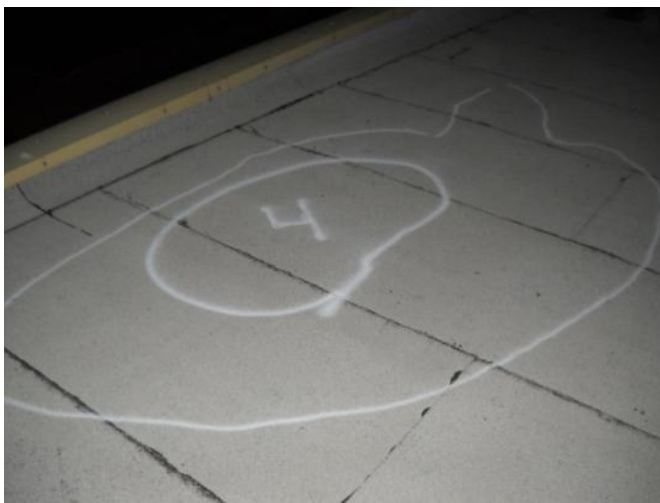
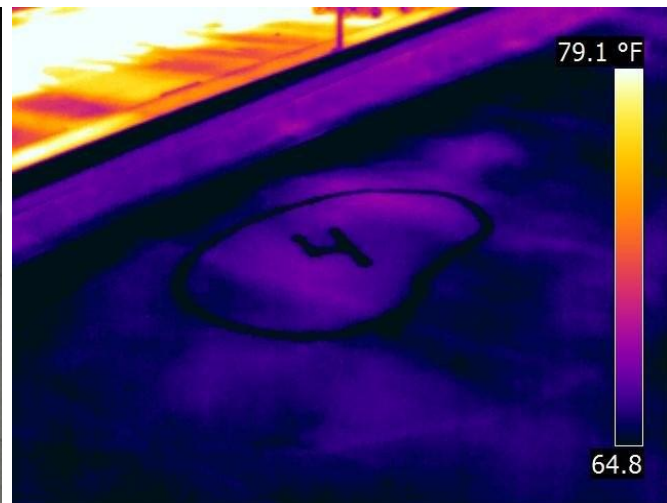
ANOMALY AREA: 4

Notes: Suspect area of moisture as indicated.

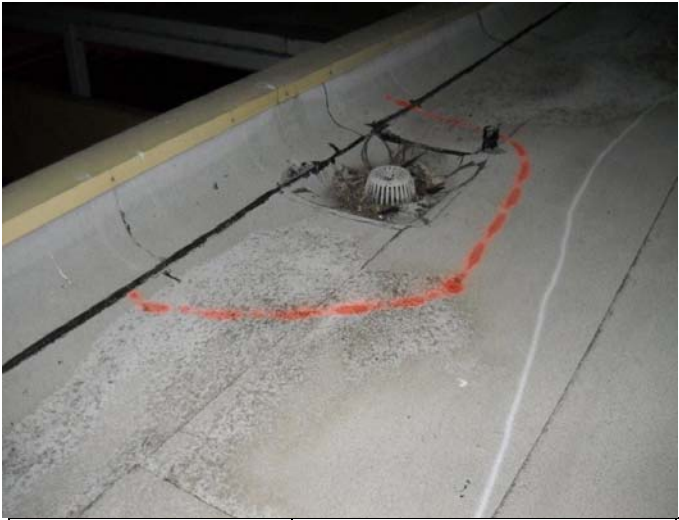
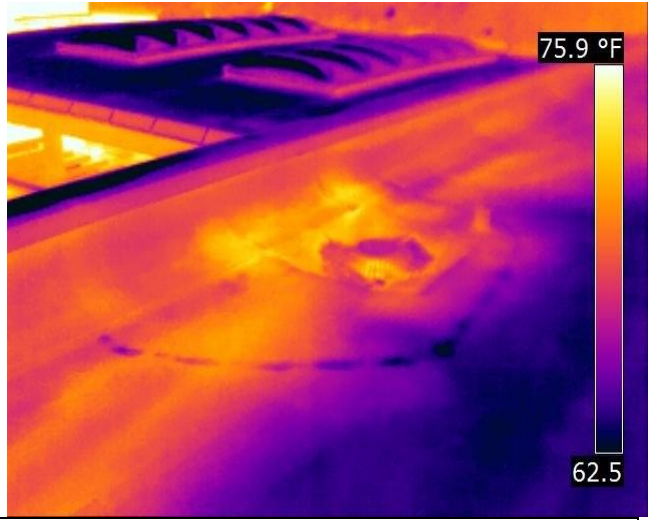
ANOMALY AREA: 5	Date: 8/6/2009 11:16:18	Notes: Suspect area of moisture as indicated.
------------------------	--------------------------------	--

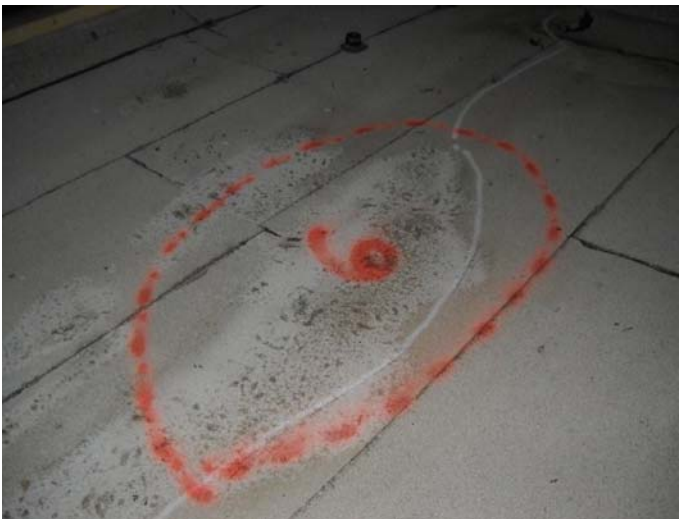
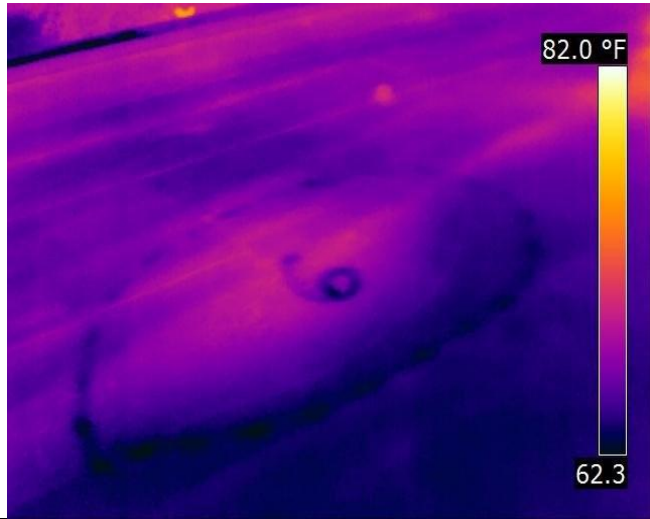
ANOMALY AREA: 6	Date: 8/6/2009 11:21:01	Notes: Suspect area of moisture as indicated.
------------------------	--------------------------------	--

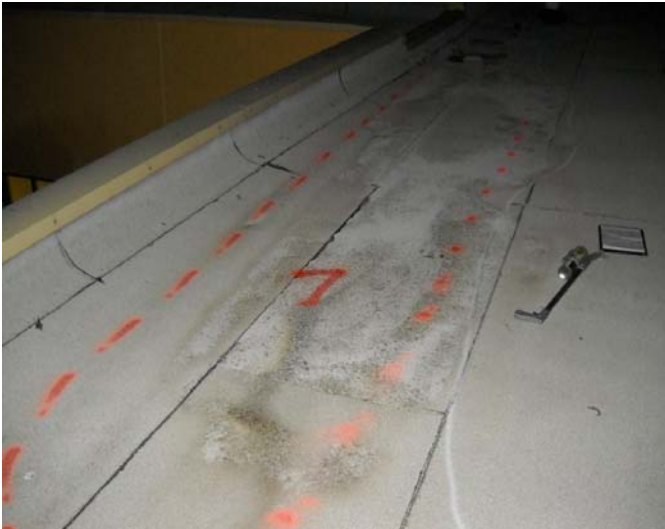
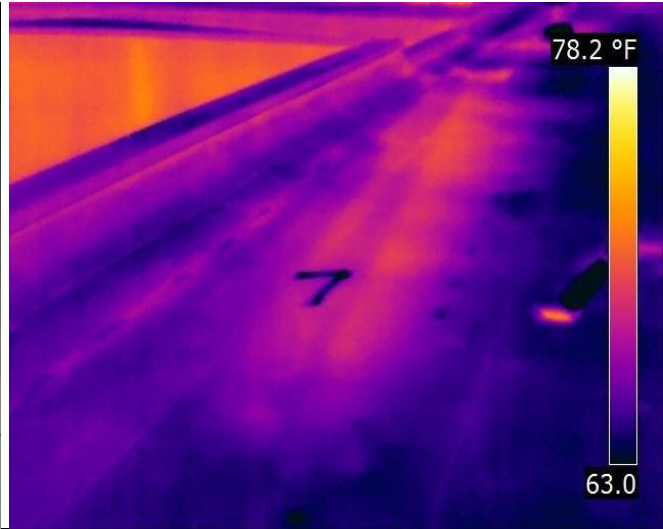
ANOMALY AREA: 7	Date: 8/6/2009 11:39:50	Notes: Suspect area of moisture as indicated.
------------------------	--------------------------------	--

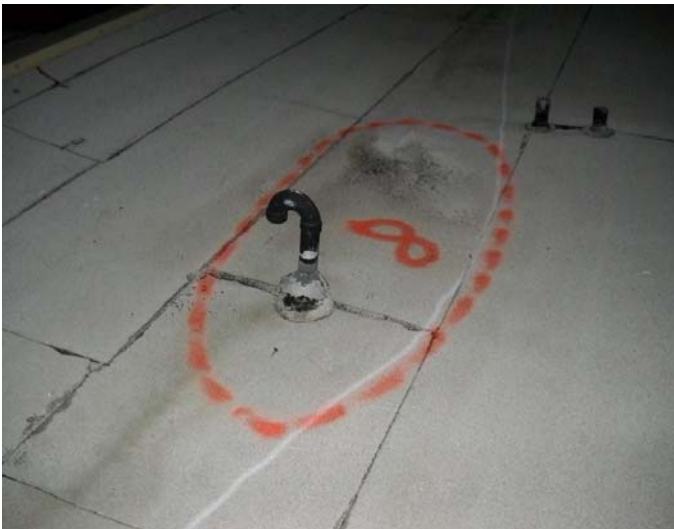
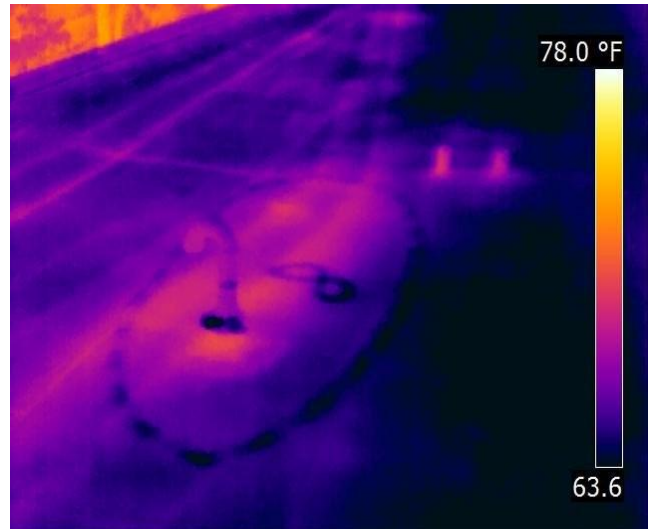
ANOMALY AREA: 8	Date: 8/6/2009 11:55:45	Notes: Suspect area of moisture as indicated.
------------------------	--------------------------------	--
